**DEPARTMENT OF TRANSPORTATION****DIVISION OF ENGINEERING SERVICES**

Contract #: 04-0120F4Cty: SF/ALA Rte: 80 PM: 13.2/13.9File #: 13.28**WELDING INSPECTION REPORT****Resident Engineer:**Pursell, Gary**Address:** 333 Burma Road**City:** Oakland, CA 94607**Report No:** WIR-009244**Date Inspected:** 25-Sep-2009**Project Name:** SAS Superstructure**OSM Arrival Time:** 700**Prime Contractor:** American Bridge/Fluor Enterprises, a JV**OSM Departure Time:** 1530**Contractor:** Oregon Iron Works Clackamas, Or.**Location:** Clackamas, OR**CWI Name:** Mike Gregson, Jose Salazar**CWI Present:** Yes No**Inspected CWI report:** Yes No N/A**Rod Oven in Use:** Yes No N/A**Electrode to specification:** Yes No N/A**Weld Procedures Followed:** Yes No N/A**Qualified Welders:** Yes No N/A**Verified Joint Fit-up:** Yes No N/A**Approved Drawings:** Yes No N/A**Approved WPS:** Yes No N/A**Delayed / Cancelled:** Yes No N/A**Bridge No:** 34-0006**Component:** Hinge K Pipe Beams**Summary of Items Observed:**

Hinge-K Pipe Beam Assembly 102A-2: 9/25/09

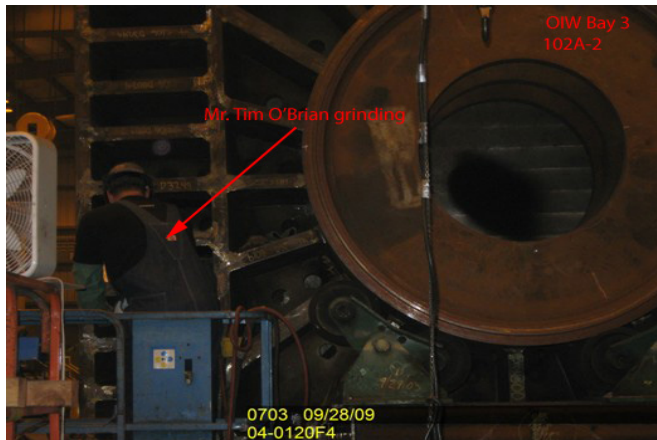
QA Inspector noticed that welder #O6, Mr. Tim O'Brian and #J6, Mr. Craig Jacobson, were in-process of grinding and performing weld clean-up, on the PJP and fillet welds stiffeners to a111-2 forging and a107/b106/ab106 stiffeners. QA Inspector spoke with lead QC Inspector Mike Gregson and Mr. Gregson explained that the blending and weld clean-up was being performed on the weld transitions and weld spatter/undersize welds were being repaired, which were previously marked by QC Inspector Jose Salazar. Mr. Gregson also explained that the completed fillet and PJP welds on the radial stiffeners, which were found to be visually acceptable per AWS D1.5 and contract requirements, were in process of 100% magnetic particle inspection by QC Inspector Jose Salazar. QA Inspector noted that the in-process visual and magnetic particle testing by OIW QC Inspectors appeared to be in compliance with AWS D1.5 and contract requirements. See attached picture below.

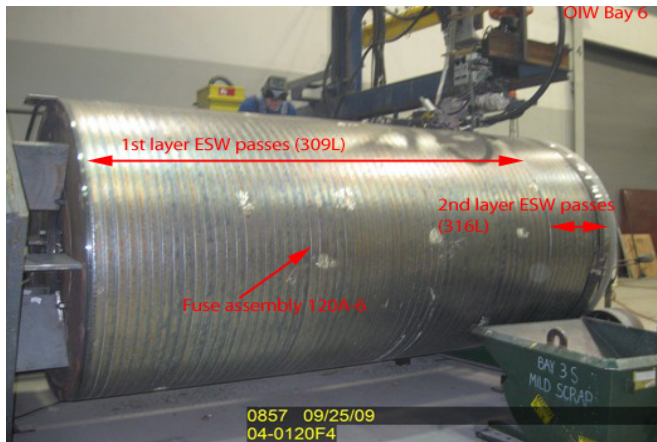
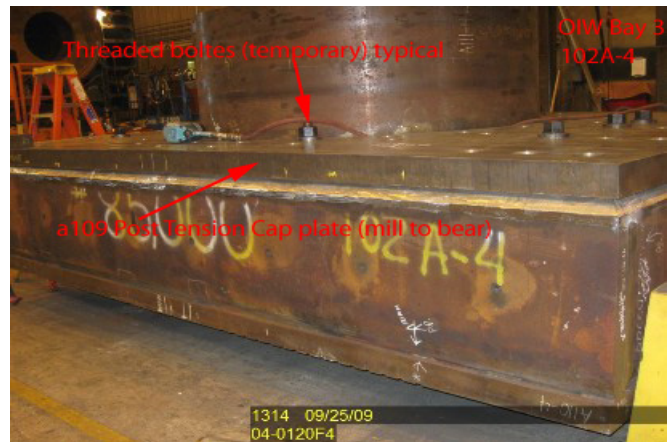
Hinge-K Pipe Beam Assembly 102A-4: 9/25/09

QA Inspector randomly witnessed OIW Lead, Mr. Troy Smith and Mr. Randy Kleeman were in-process of fitting the a109 Post Tension Cap plate into position. Mr. Troy Smith previously explained to QA Inspector that once the a109 Cap plate was in-position and fit, a series of threaded bolts would be placed in the existing bolt holes and tightened, to eliminate the possibility of warping and distortion of the a109 Cap plate, during the FCAW tacking. Note: QA Inspector noted that the a109 Post Tension Cap plate had been fit-up, later in the work shift and a series of threaded bolts had been placed and tightened at random locations, as referenced above, to possibly eliminate the a109 plate distortion during the FCAW tacking. QA Inspector later spoke with QC Inspector Jose Salazar and Mr. Salazar explained that the mill to bear contact surface, between the radial stiffeners and a109 Post Tension Cap Plate, had been verified. Mr. Salazar explained that a mirror and a feeler gauge had been utilized, to verify these contact points at all accessible locations (through the existing drilled holes) and approximately 100% mill to bear contact was noted by Mr. Salazar, in accordance with AWS D1.5 and contract requirements. QA Inspector verified that the mill to bear contact surface, between the a109 Post Tension Cap plate and radial stiffeners, was in compliance with AWS D1.5 and contract requirements, utilizing a .5mm feeler gauge and noted there was approximately 100% contact, through the pre existing drilled holes in the a109 Post Tension Cap plate. See attached pictures below.
